## Overview

Currawong Engineering's CBS-20 CAN servo is designed to meet the highest requirements of reliability by using class leading components to minimise wear. These components include a brushless motor, metal gears and aluminium chassis.

To investigate the reliability in a real-world setting, Currawong conducted a 1000-hour endurance test on the CBS-20 servo. The experiment was a case study of a production servo (serial number 105), which underwent tests for linearity, backlash, and performance under load at routine intervals. The tests as outlined in this report demonstrated that the performance degradation of the servo over the thousand hours under typical use was minimal, with an almost complete restoration to baseline following the installation of new gears.

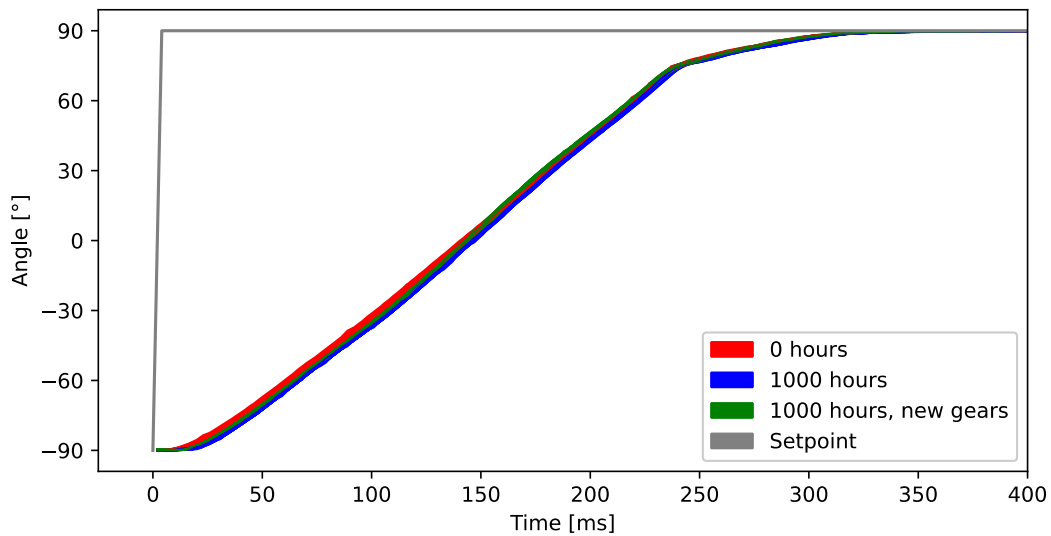
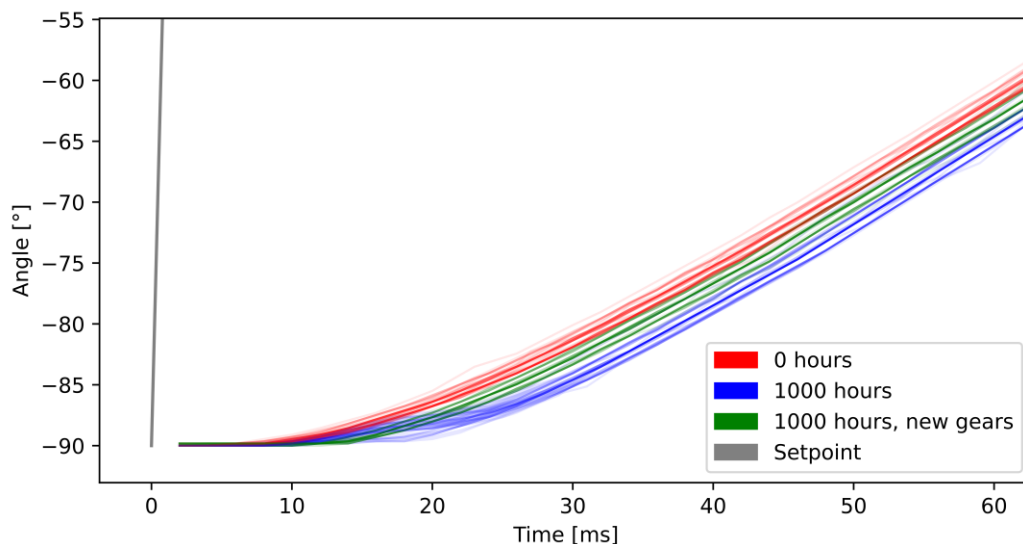
Figure 4- Step response at various test intervals

Following 1000 hours of testing the step response was still strong albeit slightly slower than the baseline test at 0 hours. The tracking error (see Appendix A) was measured and compared at each interval.

The tracking error was unchanged until after 300 hours (Table 2). Whilst after 300 hours there was a statistically significant increase in the tracking error, for most customer applications this small degradation in transient response is not relevant, especially if a velocity/acceleration limit is in effect.

Installing new gears restored the servo to baseline tracking error. Note that from 160ms to 220ms in Figure 4 the '1000 hours, new gears' is closer to the setpoint than the '0 hours' data. This occurred as by chance the new set of gears/lubrication produced more precise function during this period. This indicates that in practical applications variance in tracking error between servos could dominate the tracking error increases due to wear. However, this was not proven in this case study.

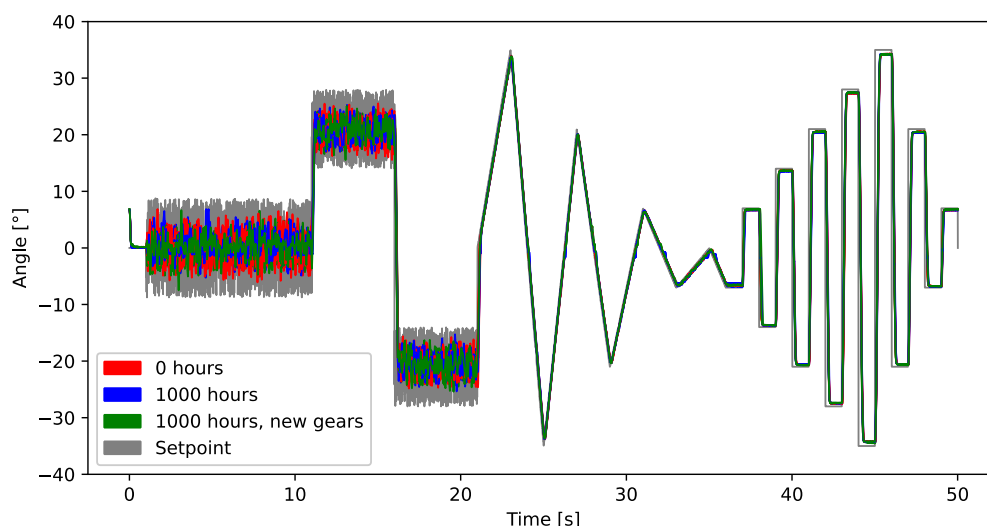
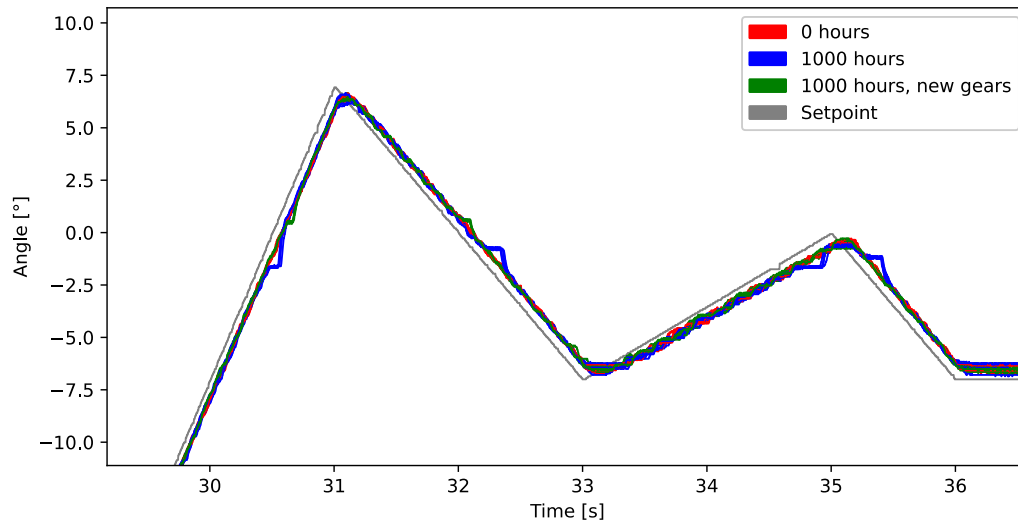
**Figure 6- Load response at various test intervals**

Under load, the servo exhibited wear around  $-1^\circ$ , where instead of smoothly tracking the triangle wave it would stop moving for 150ms. This was attributed to wear on a particular gear tooth on the output shaft. Whilst no particular gear was identified, given that 'blip' did not repeat up the triangle wave we can ascertain it was almost certainly the output shaft. As the gear replacement corrected the issue, potentiometer wear was ruled out as a cause.

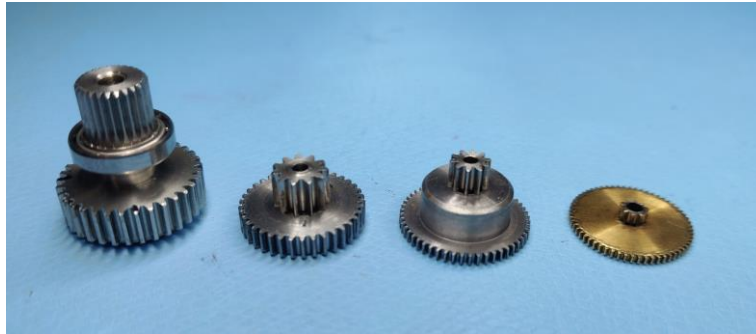
The servo gears were routinely inspected; however it was only after 1000 hours and cleaning the lubricant that inspection was able to reveal the full extent of the wear. The lubricant on the gears was discoloured due to metal filings from wearing gears.

**Figure 8- Servo gears, cleaned after the test ready for inspection. Gears referenced as 1 to 4, left to right.**

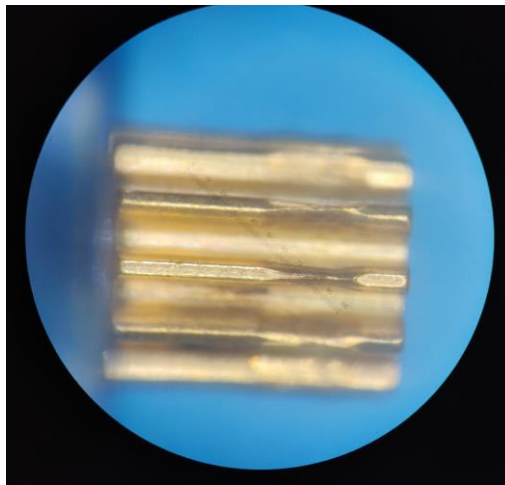
**Figure 9- Pinion gear**

Currawong notes that in rare cases some customers have experienced pinion gear (motor gear) failure whilst running the servo under very hard conditions with reduced, or in some instances removed velocity and acceleration limits. Whilst Figure 9 shows that the pinion gear does exhibit wear, the wear is characteristic of a servo with a thousand hours of loaded use and does not match the accelerated wear experienced in the aforementioned cases.

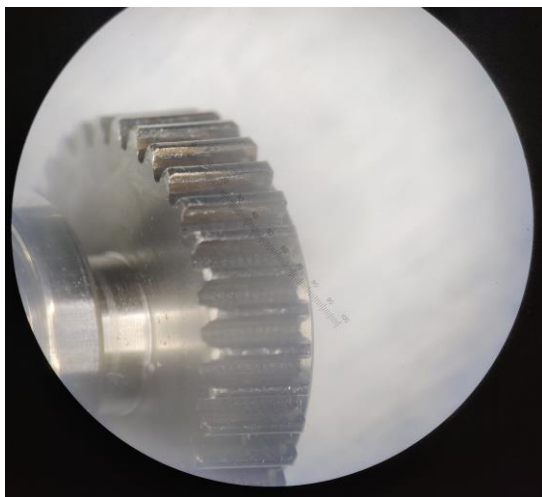
**Figure 10- Gear 1**

This backlash was caused by worn teeth on the output shaft gear and the mating gear. The worn teeth increased the clearance between the teeth so that the shaft could move without resistance (in the 2° range). Installation of the new gears eliminated the backlash.

Each of the photographs (Figure 9 to Figure 13) highlights the most worn section of the gear. On the output shaft in Figure 10 the flanks were worn exposing a rough surface. In Figure 13 the tooth thickness increases at the base of the gear where the mating gear did not contact the entire gear tooth face.
