## Overview

Currawong Engineering's CBS-20 CAN servo is designed to meet the highest requirements of reliability by using class leading components to minimise wear. These components include a brushless motor, metal gears and aluminium chassis.

To investigate the reliability in a real-world setting, Currawong conducted a 1000-hour endurance test on the CBS-20 servo. The experiment was a case study of a production servo (serial number 105), which underwent tests for linearity, backlash, and performance under load at routine intervals. The tests as outlined in this report demonstrated that the performance degradation of the servo over the thousand hours under typical use was minimal, with an almost complete restoration to baseline following the installation of new gears.

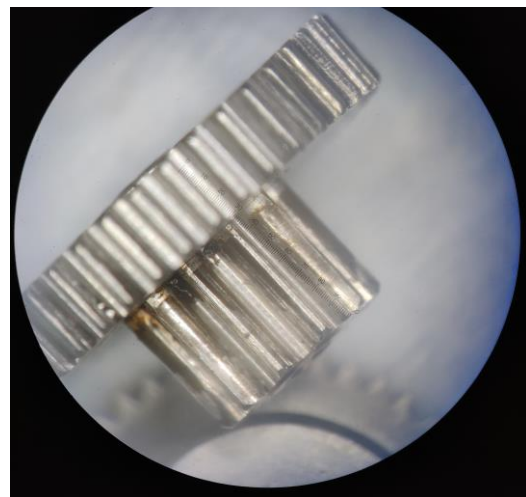
**Figure 11- Gear 2**

Each of the photographs (Figure 9 to Figure 13) highlights the most worn section of the gear. On the output shaft in Figure 10 the flanks were worn exposing a rough surface. In Figure 13 the tooth thickness increases at the base of the gear where the mating gear did not contact the entire gear tooth face.
